**US Army Corps
of Engineers®**

Notice of Preparation

Project Name: Additional Repairs to the Yakima Authorized Right Bank Levee, Naches River,
Yakima, Washington

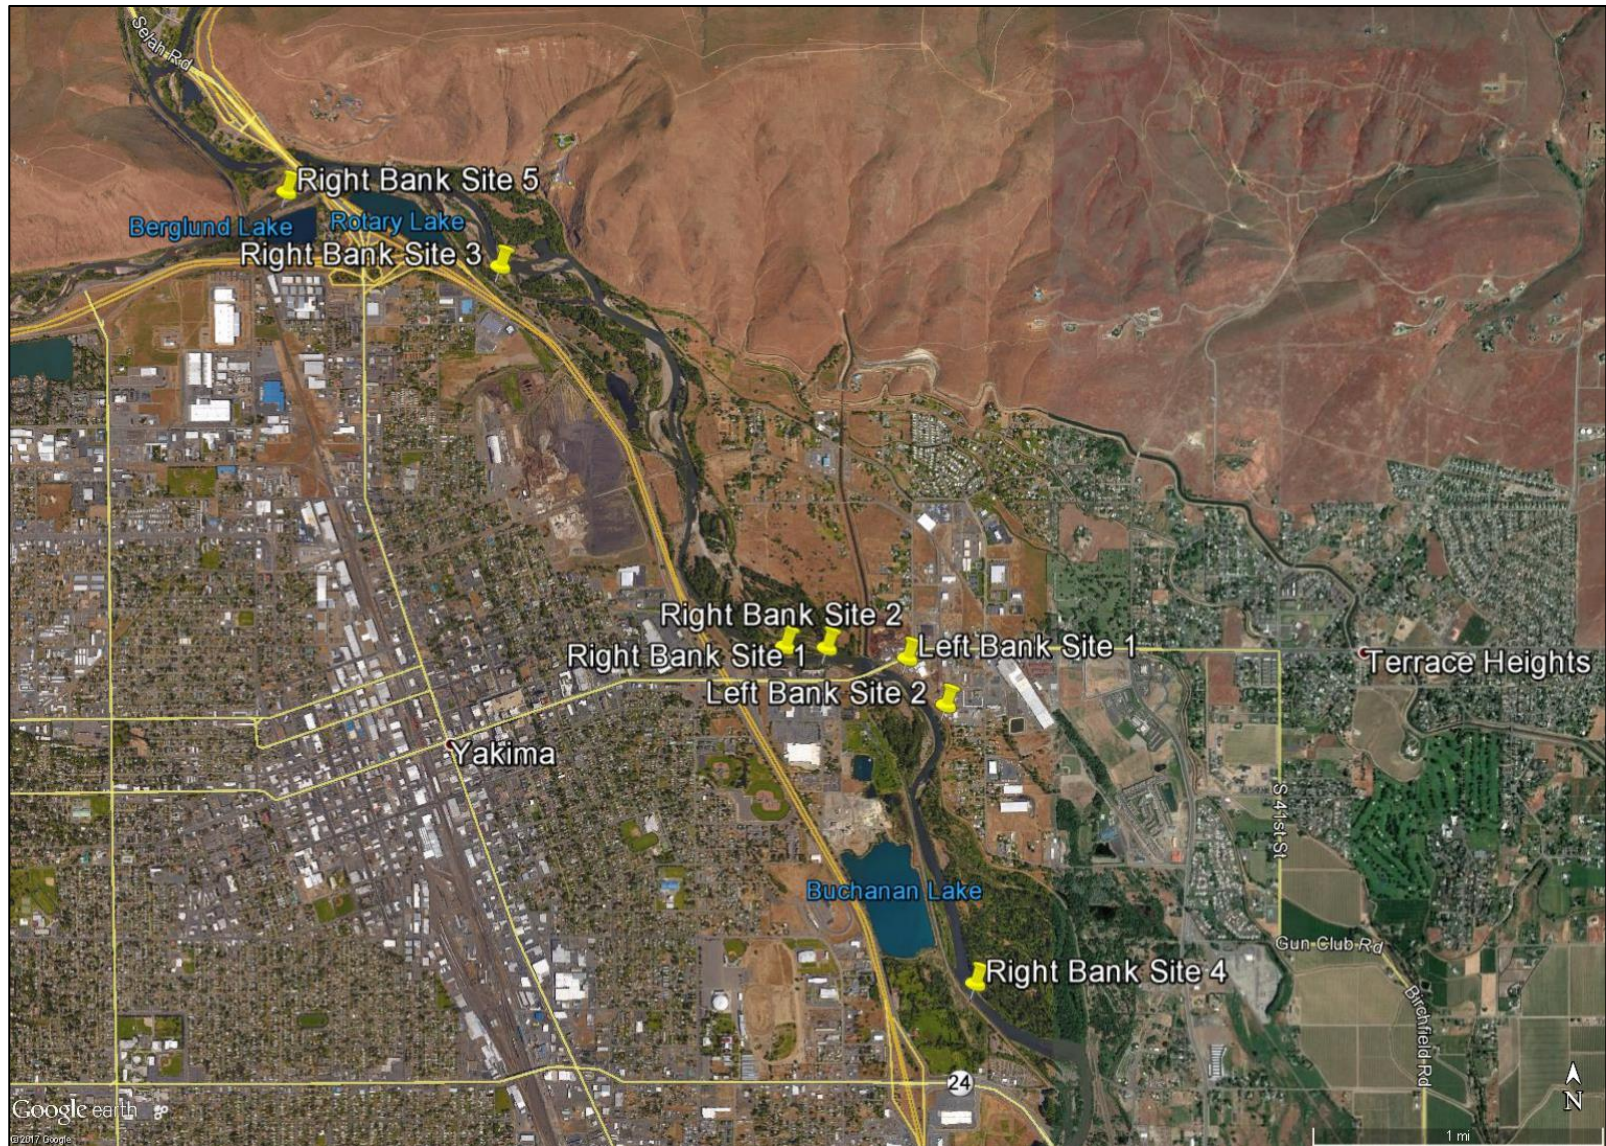
Figure 1. Location of Right Bank Site 5 and all previous repairs from the two previous NOPs. All Left Bank sites and Right Bank Site 1 through 4 have been constructed. Right Bank Site 5 was discovered in late spring 2017.

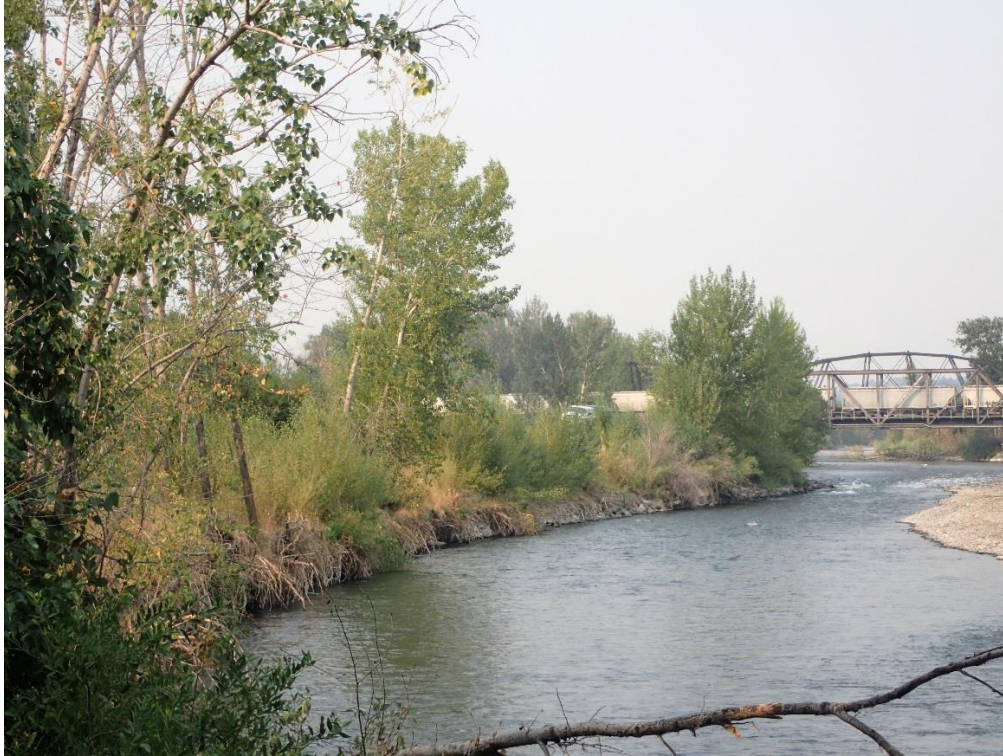
Figure 2. Typical example of damage along levee toe. Photo taken from under the I-82 Bridge, looking upstream along the Naches.

This third NOP updates the previous action with an additional site that was discovered by the non-federal sponsor. The additional site (RB Site 5) is on the Naches River near its confluence with the Yakima River. Right Bank Site 5 was damaged along 830 feet. Low flows during the summer of 2017 allowed of the Spring 2017 damage to be seen out of the water. In addition to that, a portion of the bicycle path under the bridge began to fail, which prompted a closer inspection. Although the damage occurred prior to the promulgation of the May 2017 FONSI, the federal sponsor did not notice and report the damage until afterwards. Even though Site 5 is distinct from the other Yakima Right Bank Federal Levee segments addressed in that prior EA, because repair work is still being completed and in light of the close connection between the sections of the Yakima River Right Bank Levee damaged in 2015 and 2017, it is appropriate that the Site 5 repair be viewed as the latest episode in an ongoing course of agency action, and addressed under NEPA in a Supplemental EA. This NOP incorporates the additional Right Bank site into the proposed action. Draft repair plans to Site 5 are located in Attachment A and typical damage at Site 5 is shown in Figures 2 and 3. Damage is primarily along the levee toe, with some damage underneath the bridge.

Sloughed material within reach of an excavator at the scoured toe would be removed from the river and the levee prism would be reconstructed in its originally designed and pre-damaged location. Total construction length, including smooth transitions into the existing slopes, would be 830 linear feet. All work would occur within the designed and pre-damage footprint and profile at Site 5. From start to completion, the repair is expected to take 4 weeks during January and February, 2018.

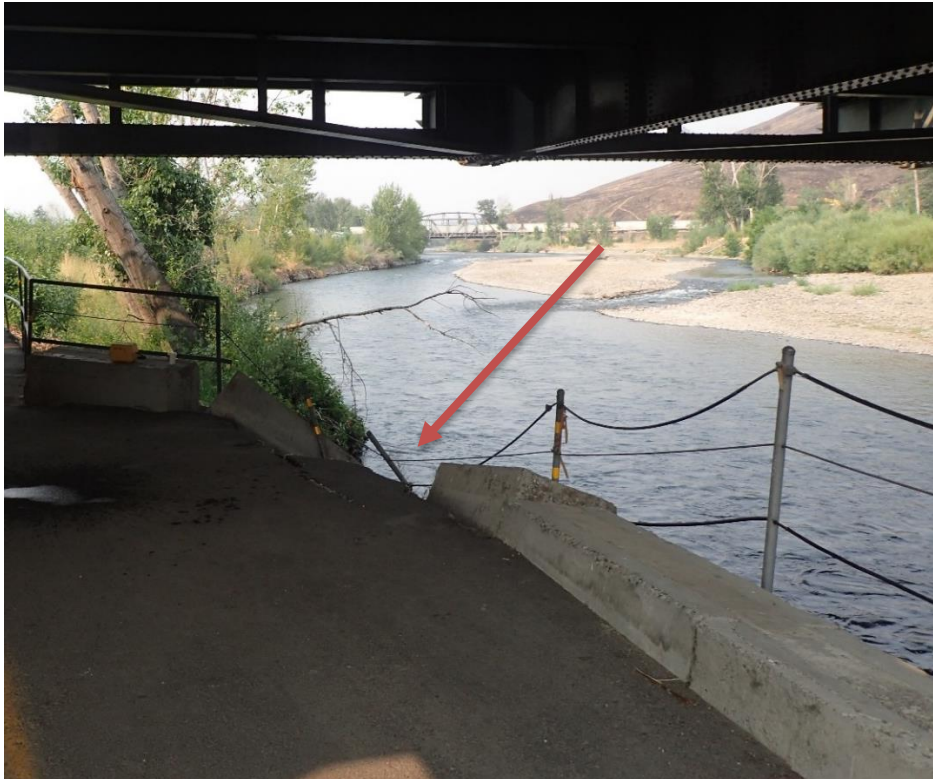
Figure 3. Damage located under the bridge includes erosion along the toe and undermining of the trail so that it is falling into the river.

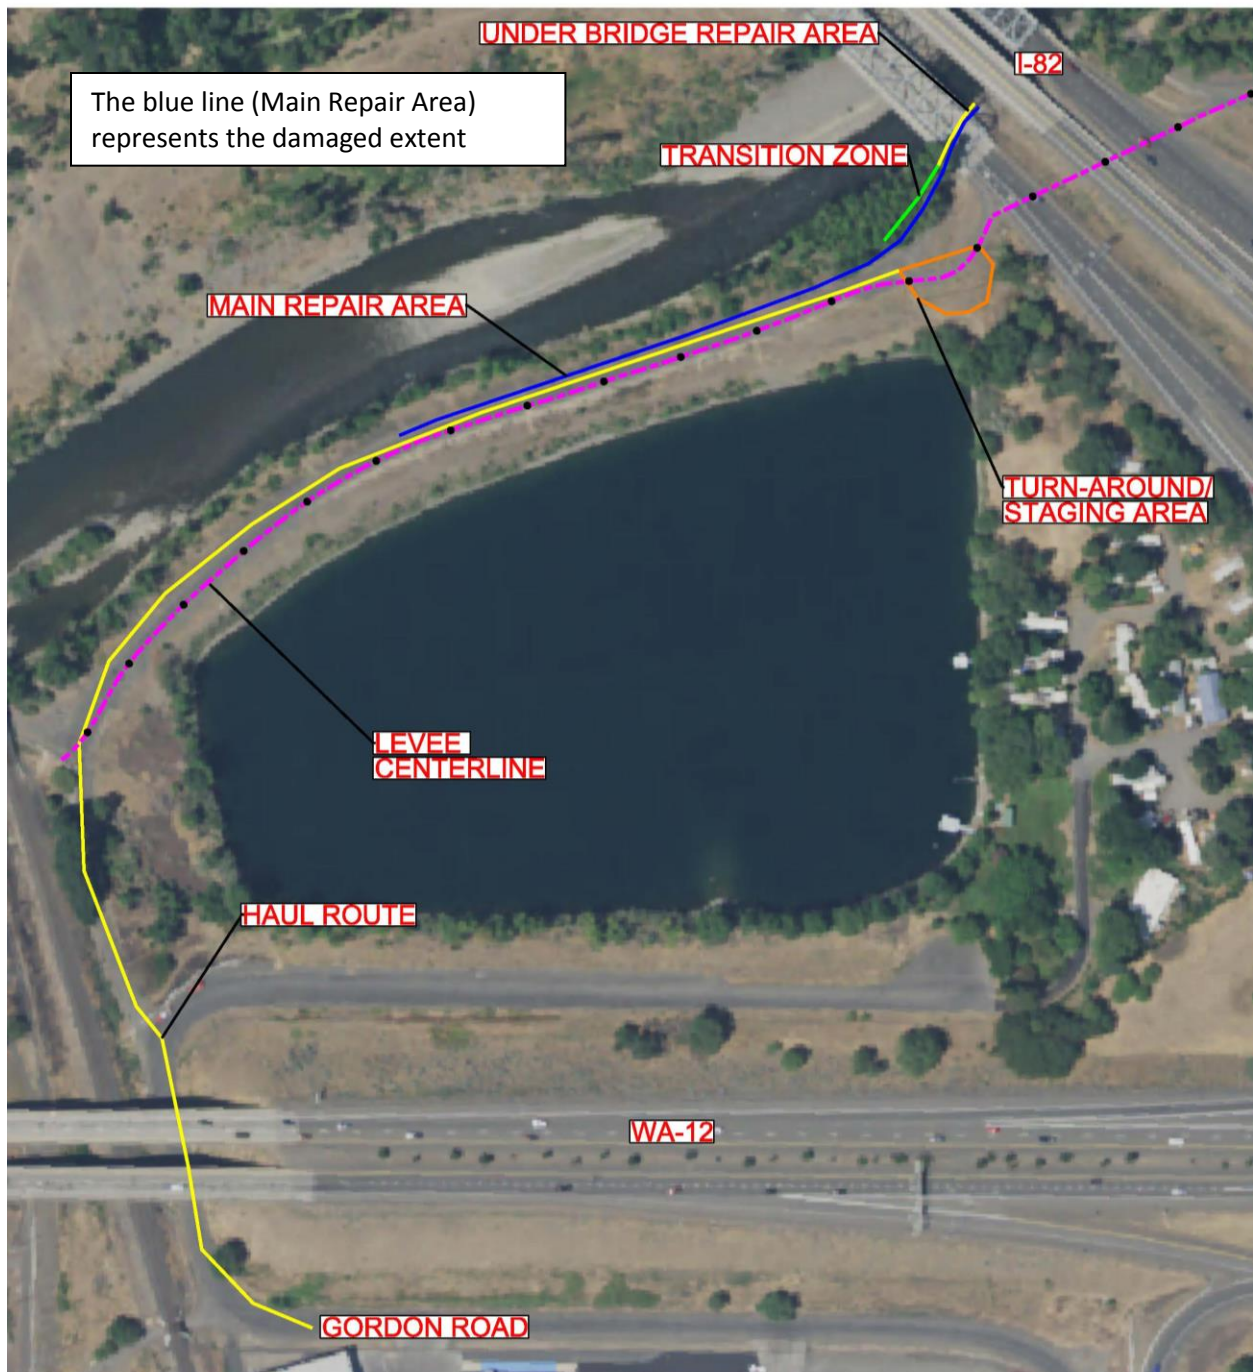
General Site Plan including damage and access.

The Repair in Kind Alternative would restore the levee to pre-flood conditions, and previous levels of protection to the damaged section. Attachment A shows the proposed repair for the additional Right Bank Site 5 repair. Under this alternative Site 5 would be repaired in-kind to its pre-damaged condition and alignment.

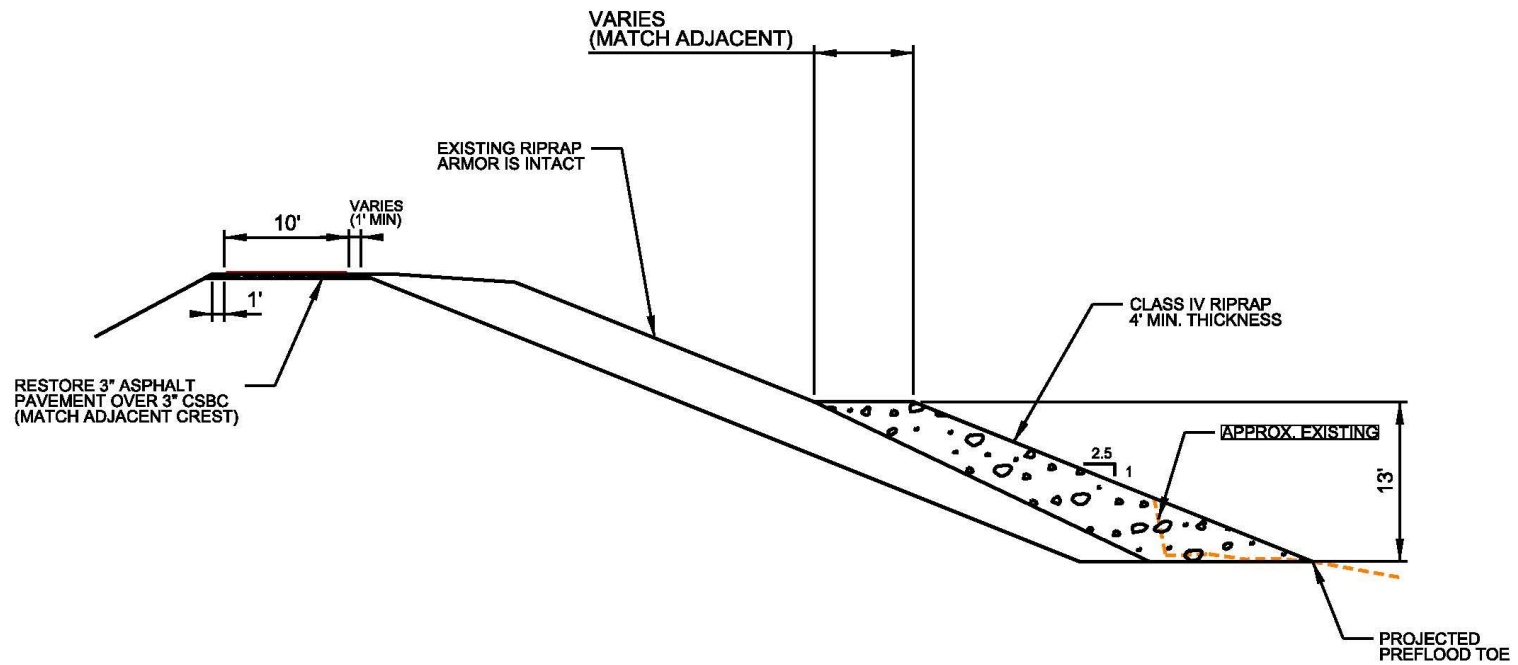
Typical Cross Section. Bench Varies in width.

The levee is approximately 2 to 8 feet high on the landward side and predominately composed of silty, sandy, gravel riverbed material with a rock armor blanket of Class III to IV riprap on the riverward slope. The landward slope of the levee is approximately 2H: 1V, while the riverward slope ranges from 2H:1V to 3H:1V. The levee crest is about 10 feet wide and surfaced with asphalt pavement. The launchable toe at Site 5 has a variable length and height. Typical launchable toes along the levee are 5 feet tall and extend 10 feet riverward from the base of the levee slope.
